Survitec Service & Distribution Ltd (Crewsaver)

Servicing / Technical bulletin number: 062

Subject: Crewfit 165N Sport Harness Webbing modification removal

Amendment to 01194H Crewfit Sport with Harness

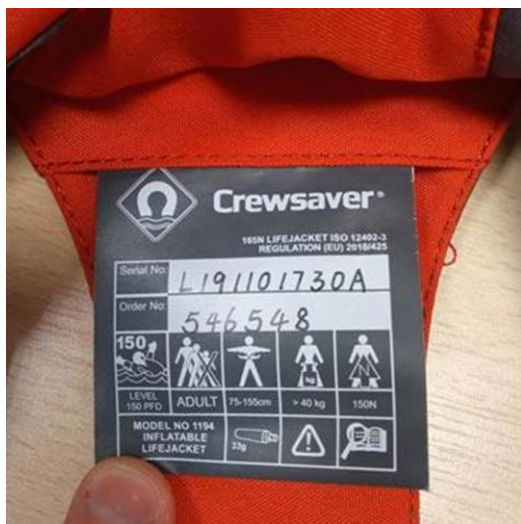
The numbers can be found on the label of the lifejacket (shown below) – tucked in a pocket located on the join of lifejacket cover back strap and collar.

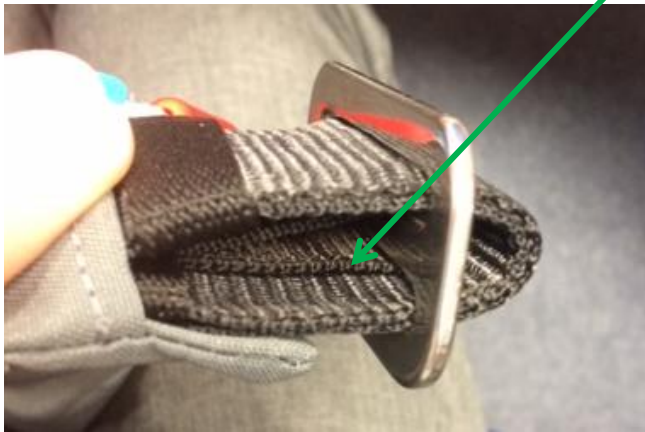
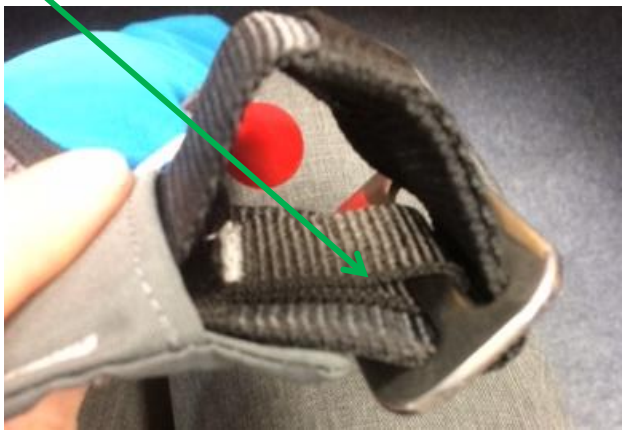
GOOD STOCK
3 layers of webbing running through interlock buckle.
Inner webbing retainer approx. 25mm width.

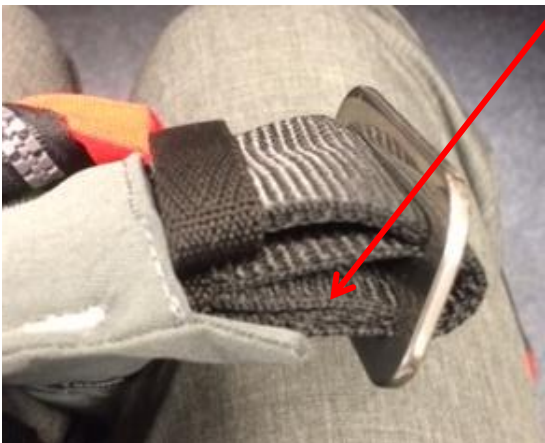
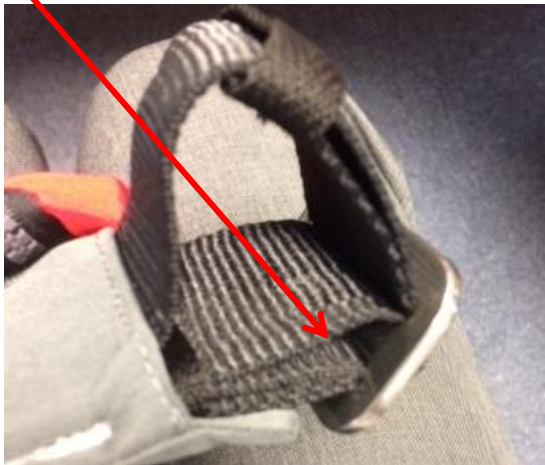
AFFECTED STOCK
3 layers of webbing running through interlock buckle.
Note the larger Inner webbing retainer width approx. 50mm.

Attached with this bulletin is a copy of the rework specification you will need to follow to correct the issue. Please ensure Crewsaver are consulted prior to the work if you have concerns.

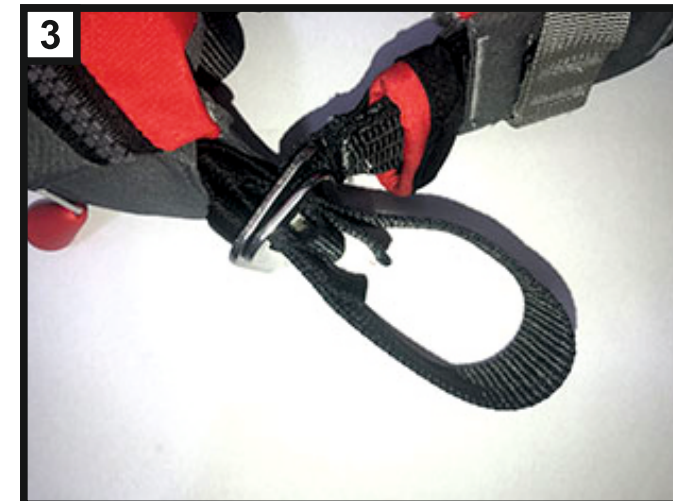
There will be three webbings visible
 1 50mm Buckle retainer
 2 50mm webbing mod kit
 3 50mm belt
