## CREWSAVER SERVICING AND MAINTENANCE BULLETIN No. 32

**Issued to:** All Service Stations + Service certificate holders  
**DATE ISSUED:** 12 October 2011  
**SUBJECT:** Hammar Safety Alert  
**ISSUED BY:** Dean Toone  
**EXP DATE:** Not Applicable

## Safety Alert – Inflatable lifejackets equipped with Hammar Hydrostatic Inflator manufactured before 2006

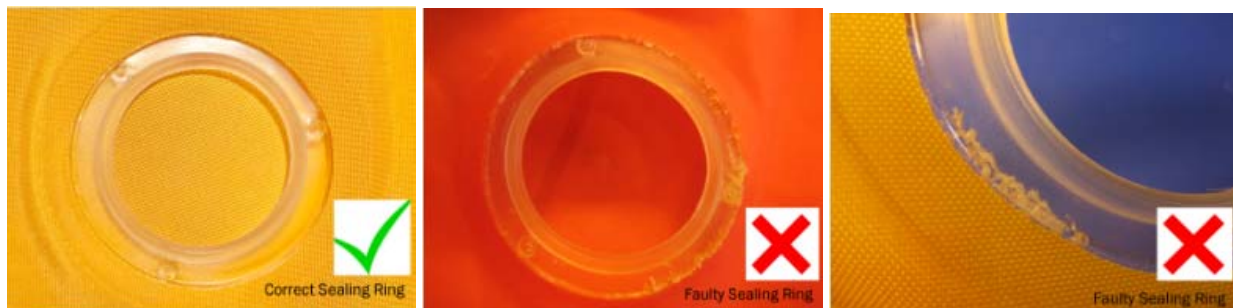
Our existing instruction to inflate the lifejacket found in all service manuals will identify any faulty sealing rings, however for additional guidance please see below:

The Hammar Hydrostatic Inflator is attached to the lifejacket with a sealing ring. In 2006, CM Hammar upgraded the sealing ring with new state of the art raw materials, to eliminate potential defects and increase long term durability. A small number of sealing rings manufactured before 2006 have suffered premature material degradation, most likely after being exposed to extreme environmental conditions. When exposed to high temperature and high humidity for a long period of time, the sealing ring might become stiffer, change colour and in severe cases cracking of the plastic may occur. The change does not occur overnight and can be detected at the recommended service or inspections.

CM Hammar are concerned that a damaged sealing ring might put the user at risk. **If you have a lifejacket manufactured before 2006 that has not been serviced recently we recommend that you contact your nearest authorized service station for an annual service.** The date of manufacture can be identified on the inside of the lifejacket cover. If you still want to do the check of the sealing ring yourself please [watch the film here for further information](#).
