## **CREWSAVER MAINTENANCE CHECK BULLETIN 46 Draft**

**ISSUED TO:** RNLI

**DATE ISSUED:** Nov 2014

**SUBJECT:** Lifejacket Lights Fitted to RNLI ILB and ALB Lifejackets.

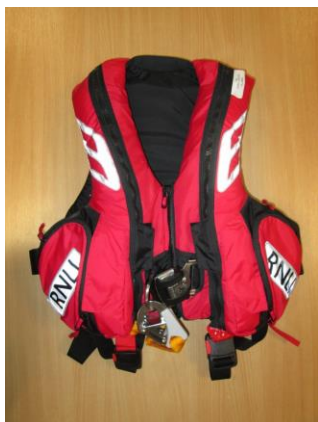
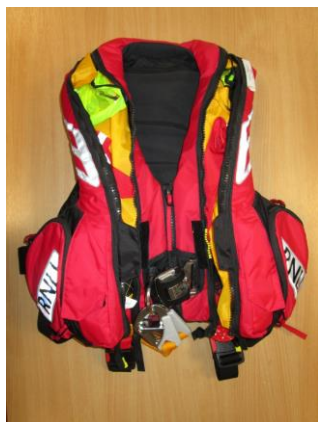
Packed Correctly

1. Wet jackets should always be opened up and dried fully before being repacked.
2. The lights should be checked at least monthly, more frequently if the jacket is in regular use.
3. The water sensor should be packed **BEHIND** the inflator, as illustrated in the photographs overleaf.

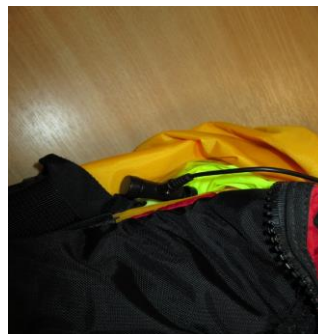
1. The lifejackets are being stored in a wet condition.
2. The water sensor of the light is being packed in front of the inflator which can form a pocket of water. This is illustrated in the photographs overleaf.

Packed incorrectly

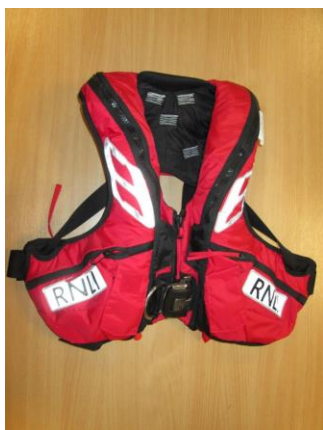
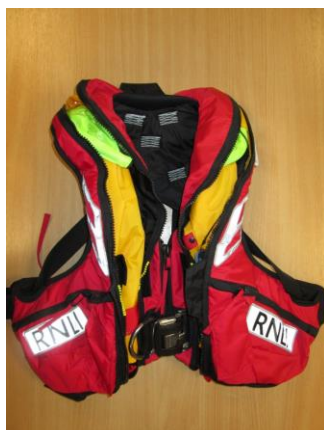
Packed Correctly

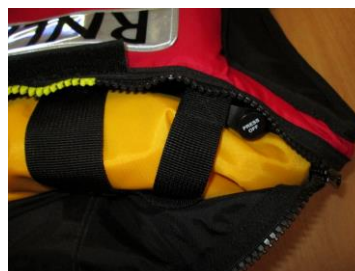
Packed incorrectly
