## CREWSAVER SERVICING AND MAINTENANCE BULLETIN No. 38

**Issued to:** All Service Stations  
**DATE ISSUED:** 4<sup>th</sup> September 2012  
**SUBJECT:** Checking the attachment of the gas flange and oral inflation tube to the inflator.  
**ISSUED BY:** Rob Angel  
**EXP DATE:** Not Applicable

### Checking and monitoring the attachment of the Gas Flange and Oral Inflation Tube

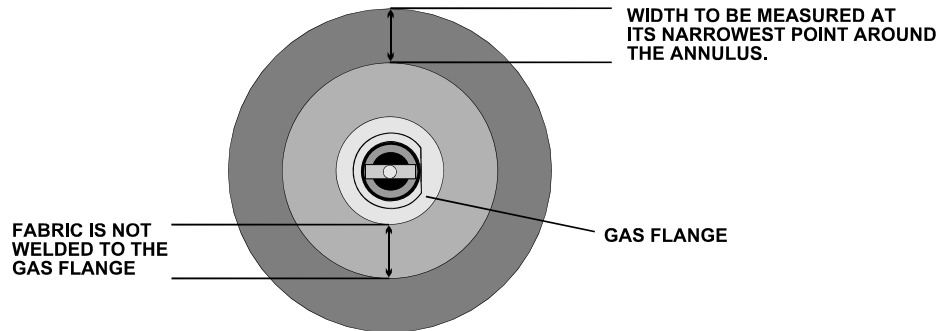
Degradation of the attachment weld of the Gas Flange and the Oral Inflation Tube can occur on older jackets depending on the climatic conditions experienced by the jacket. Newer jackets are unaffected.

2. Where the bases of the Gas Flange and Oral Inflation Tube show as a black ring, these must be measured. All Oral Inflation Tubes will be like this but some later models of lifejacket could be fitted with a Gas Flange that has a clear base. These Gas Flanges need not be checked.
3. To measure the width of the weld on the Gas Flanges first remove the automatic head. If the jacket is a Seafire Solas the rear Gas Flange must then be pulled through the neck opening to make it accessible. Measure the width of the black annulus at its narrowest point as per the diagram overleaf:

4. When measuring the width of the welds on the Oral Inflation Tubes again pull the rear Tube through the neck opening if the jacket is a Seafire Solas. Measure the width of the weld noting that the weld normally starts from the edge of the fabric. As a final test grasp the Inflation Tube and gently try to rotate it.
5. The measurements taken must be 3.00mm. or greater. If a measurement is less than 3.00mm the jacket must be returned to Crewsaver for the inflator to be replaced.
