CREWSAVER SERVICING AND MAINTENANCE BULLETIN No. 43

Issued to: GAO, CGG
DATE ISSUED: 3rd January 2014
SUBJECT: Crewfit Twin 2010 with Cowtail
ISSUED BY: Carol Champney
EXP DATE: Not Applicable

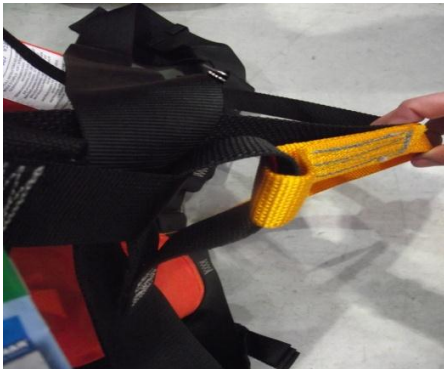
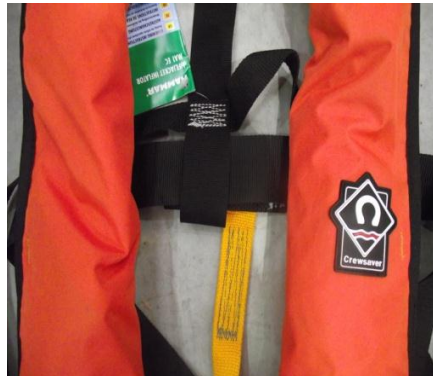
Please be advised that the threading of the cowtail on the 2010 Crewfit twin 1174-23 and 1174-24 has not been passed through the belt.

INCORRECT
 The images are showing the cowtail only attached to the cowtail retainer

To rework. Unthread the belt pass through the cowtail re thread the belt.

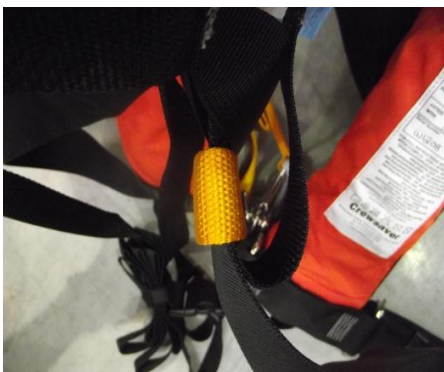
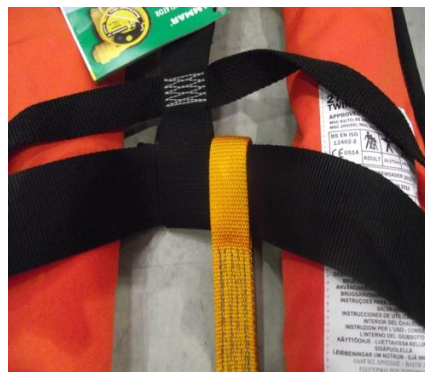
CORRECT
 The images show the cowtail attached to the belt and the cowtail retainer
