## CREWSAVER SERVICING AND INFORMATION BULLETIN No. 27

**SUBJECT:** Seacrewsader Lifejackets

### **Seacrewsader – Precautionary Warning**

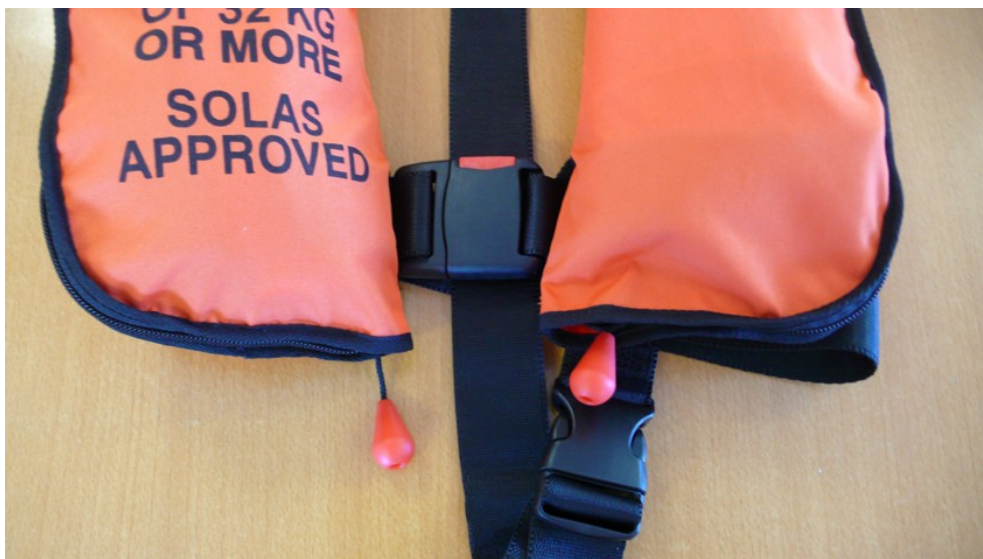
Woven nylon cord with toggle.

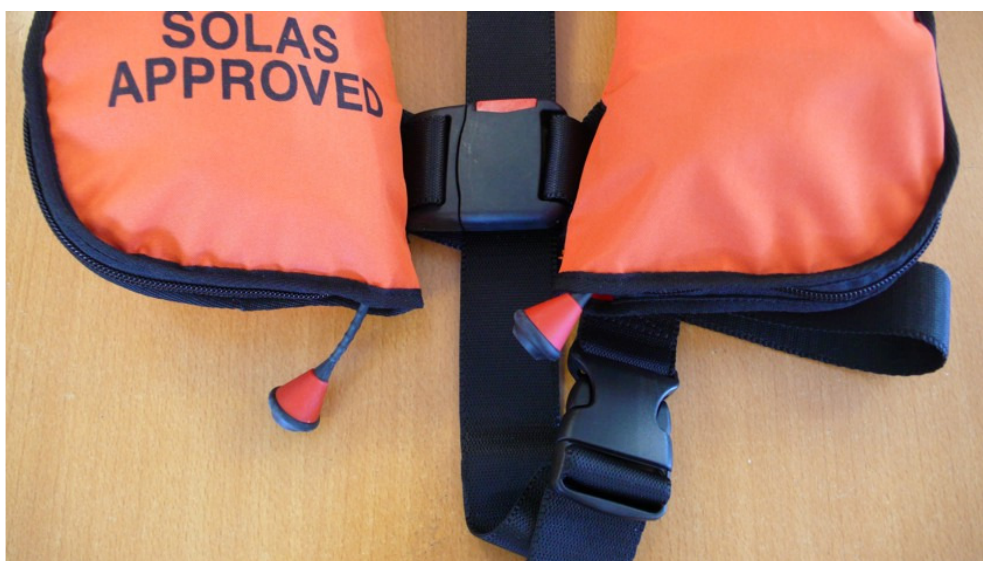
- **The twin automatic operation of both chambers is unaffected by this process and will work as the primary activation method in all cases.**
- Those lifejackets with moulded plastic pull cords are more affected as the cord stretches significantly.
- The correction can be actioned at the next service interval by replacing the moulded plastic pull cord and repacking to a new procedure.

Moulded plastic cord and toggle.

A Service and Maintenance Bulletin No.26 is issued which details the procedure for changing the moulded pull cord and includes the repack procedure.
