# CREWSAVER SERVICING AND MAINTENANCE BULLETIN No. 29

**SUBJECT:** Harvester

## Harvester Attachment Method Conversion Procedure

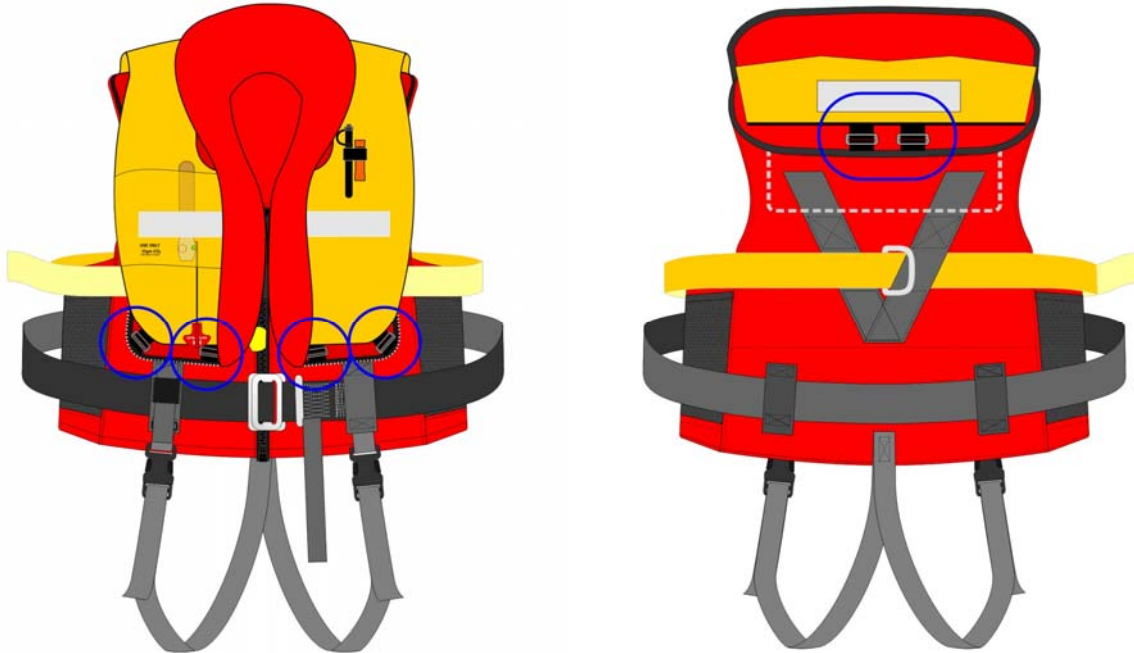
The square links that attach the inflation chamber to the cover require removal these can be located at the bottom of the front cover and at the centre back inside indicated on the above drawings by the Blue circles. There are 6 square links attached to the cover and 6 square links attached to the inflation chamber.

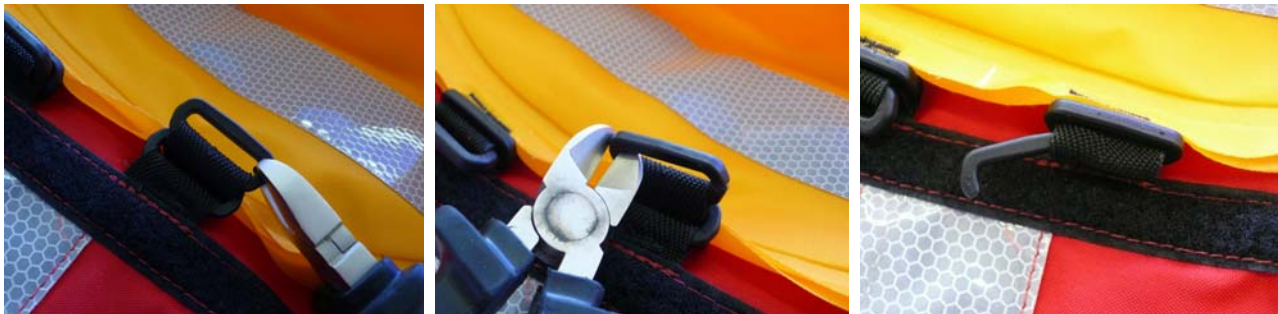
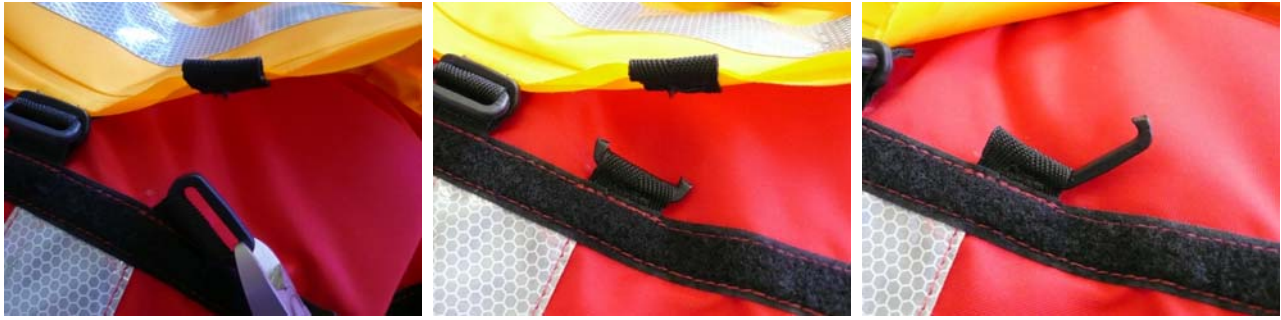
The rework detailed in this bulletin applies to a small batch of lifejackets with the serial numbers listed below. The rework has been made necessary due to a size mismatch between links holding the inflation chamber to the cover. The possibility of the links coming apart was made worse by the use of a more flexible webbing being used to attach the links.

- 1 Cut all the Harvester Square Links from the cover and the inflation chamber using sharp heavy duty cutters, leaving the webbing loops intact. The square links are quite strong so they must be snipped on both sides of the webbing loop and threaded out of the loops. These are then discarded. See photos below:
