CREWSAVER SERVICING AND MAINTENANCE BULLETIN No. 35

Issued to: RNLI
DATE ISSUED: 2nd February 2012
SUBJECT: Auto capsules
ISSUED BY: Rob Angel
EXP DATE: Not Applicable

**United Moulders Auto Capsules
with expiry date 08-2014**

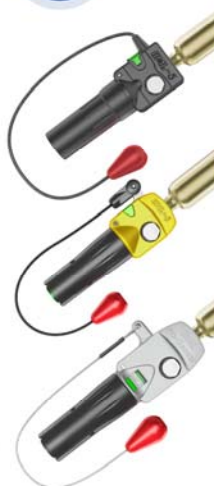
IMPORTANT:
SAFETY CHECK THE TIGHTNESS OF YOUR 08-2014 CARTRIDGES

There is no need to remove the UML inflator from your lifejacket to implement this safety check.

1. Hold the gas cylinder and head firmly in one hand.
2. With your other hand, firmly rotate the cartridge clockwise (See Image A).
3. If the cartridge 'clicks over' when you try to rotate it, (i.e. continues to rotate and will not tighten up fully) remove it completely from the firing head by turning the cartridge anti-clockwise.
4. Take a digital photo of the cartridge clearly displaying the replacement date as a record (See Image B).
5. Dispose of the cartridge as normal waste.
6. Send an email to the following address: dean@plascoat.com confirming your full name, postal address, country and contact telephone number, together with the lifejacket model, make, serial number and digital photograph of the cartridge 'Replace by date'.
7. A free of charge replacement cartridge will be sent to you by return.
